**ASSESSMENT OF JAHN PERMEABLE MORTAR SYSTEM IN A
HISTORIC BRIDGE ABUTMENT APPLICATION**

Report 2015 – 10

June 2015

Reporting on Work Plan 2011-R-05

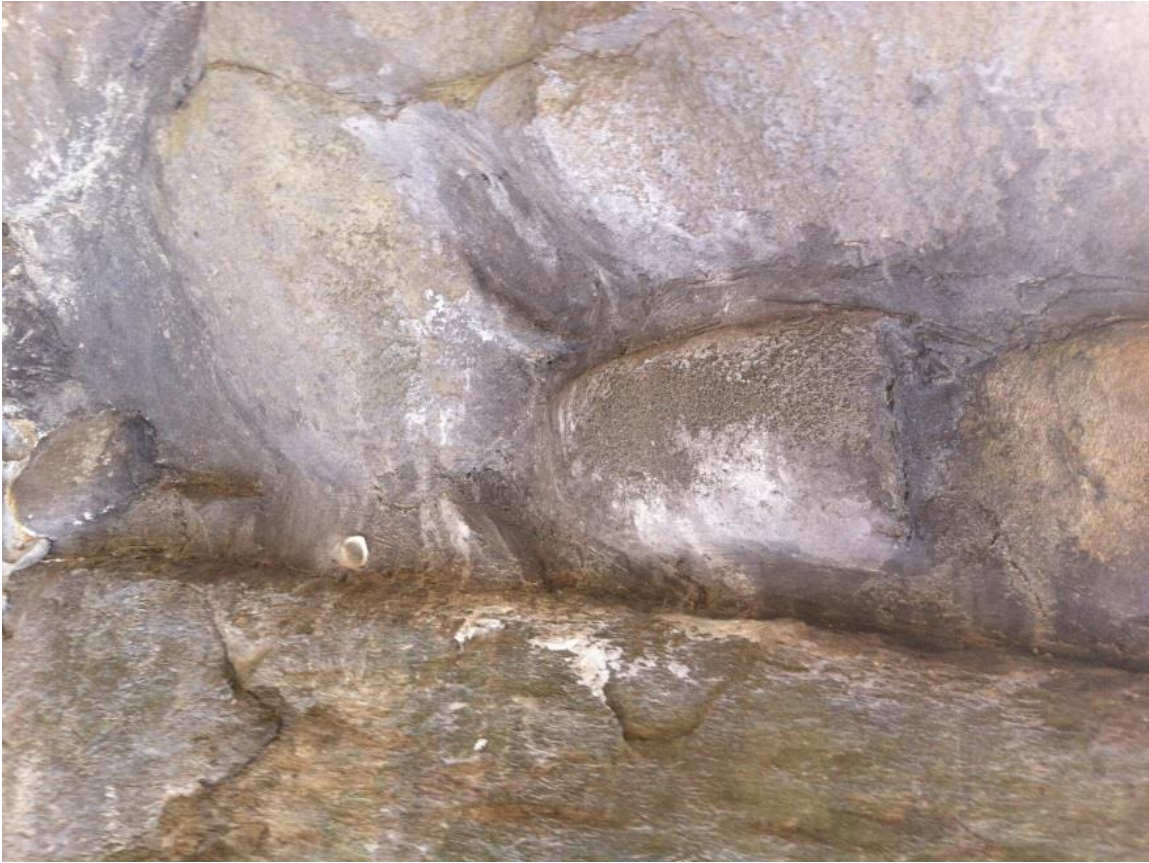
Research and Development has visited the project site once a year since the project has been completed. In a discussion with the CEO of Cathedral Stone Products, Denis Rude, he said that as the salts leach out of the interior of the pier and abutment, a white powder like substance would appear on the surface of the grout. This powder would eventually blow off the surface with wind or be washed off by rain. There were concerns that the repairs to the pier and abutment would cause an efflorescence to form in places. The use of the Jahn products was intended to prevent such efflorescence from forming. In the last two years, the white powdery substance has

been observed forming; however, it is not accumulating (Figure 18). There seems to be a consistent light dusting in places. Overall, the grout appears to functioning as expected.

Figure 18 Up-close view of white powdery residue on mortar (VTrans 2013)
