**Austin Lake Baseline Aeration Data 2017 and Year 1
Post-Aeration Data (2018)
Kalamazoo County, Michigan**

**Prepared for: Austin Lake Governmental Lake Board (ALGLB)
Pursuant to MDEQ Permit No. WRP008788
December, 2018**

**Prepared by: Restorative Lake Sciences
18406 West Spring Lake Road
Spring Lake, Michigan 49456
www.restorativelakesciences.com
info@restorativelakesciences.com**

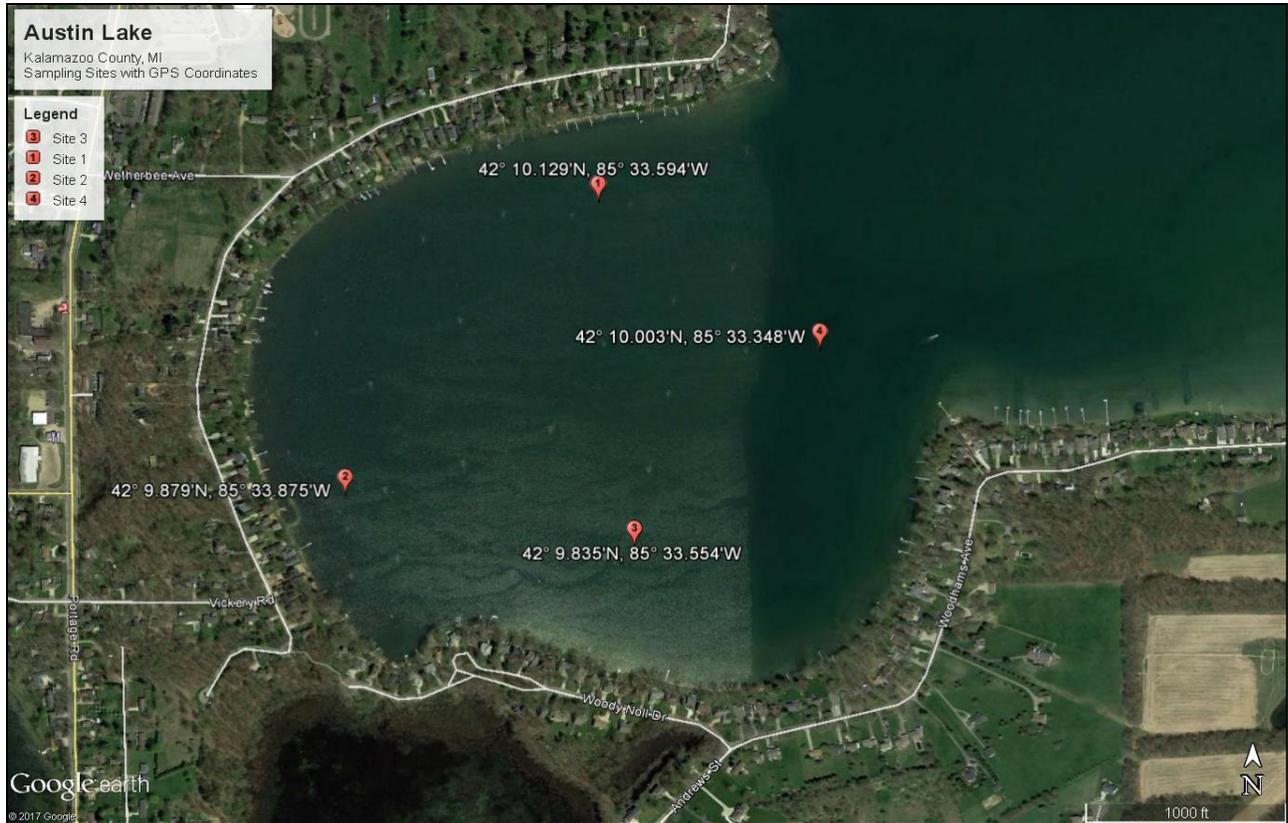
Figure 1. 2017 (baseline) and 2018 (year 1) water quality sampling locations in the South Basin of Austin Lake, Kalamazoo County, MI.

Restorative Lake Sciences sampled 4 deep basin locations on October 12, 2017. Additional data was collected at the 4 sites as required by the MDEQ for the new LFA permit on May 1, 2018, July 3, 2018, and September 14, 2018. All water quality samples were collected from the sampling locations according to Figure 1.

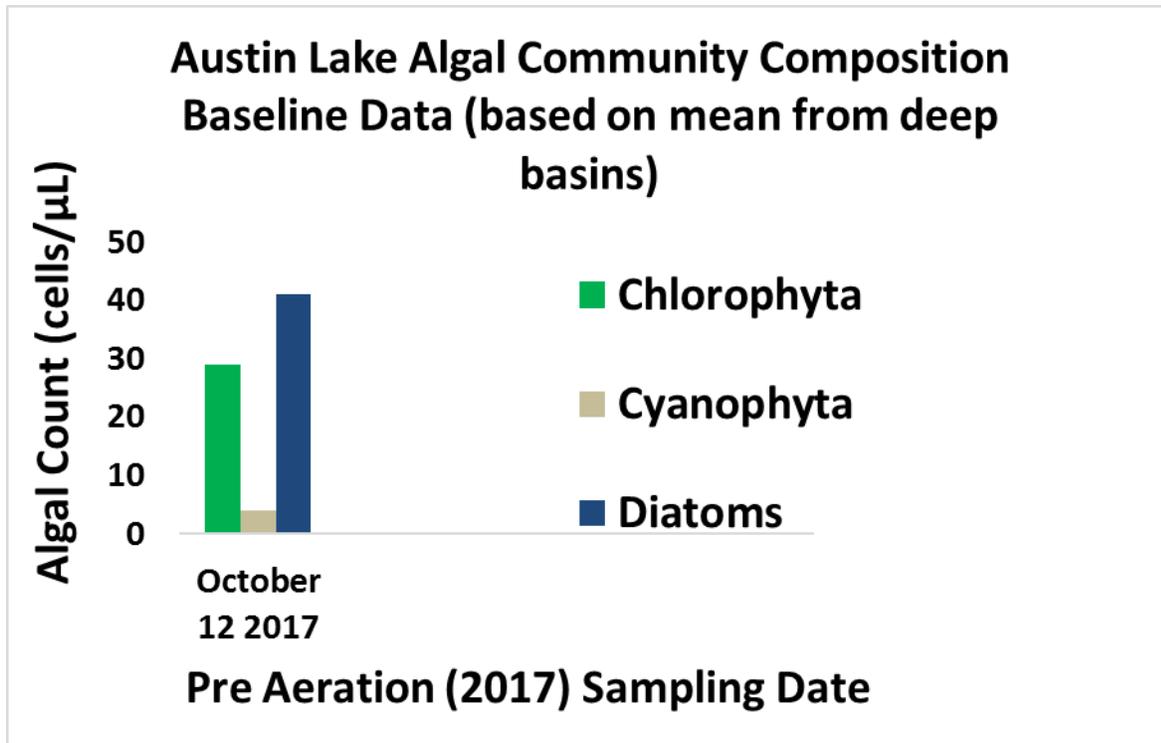
The algal genera were determined from composite water samples collected over the deep basins of the South Basin of Austin Lake on October 12, 2017 were analyzed with a compound bright field microscope. The genera present included the Chlorophyta (green algae): *Scenedesmus* sp., *Chlorella* sp., *Staurastrum* sp., *Cladophora* sp., *Mougeotia* sp., and *Radiococcus* sp., The Cyanophyta (blue-green algae): *Gleocapsa* sp.; the Bascillariophyta (diatoms): *Synedra* sp., *Navicula* sp., *Cymbella* sp., and *Tabellaria* sp. The aforementioned species indicate a diverse algal flora and represent a good diversity of alga but less blue-green algae is desirable.

Figure 2. Relative abundance of algal taxa in the South Basin of Austin Lake (October 12, 2017).

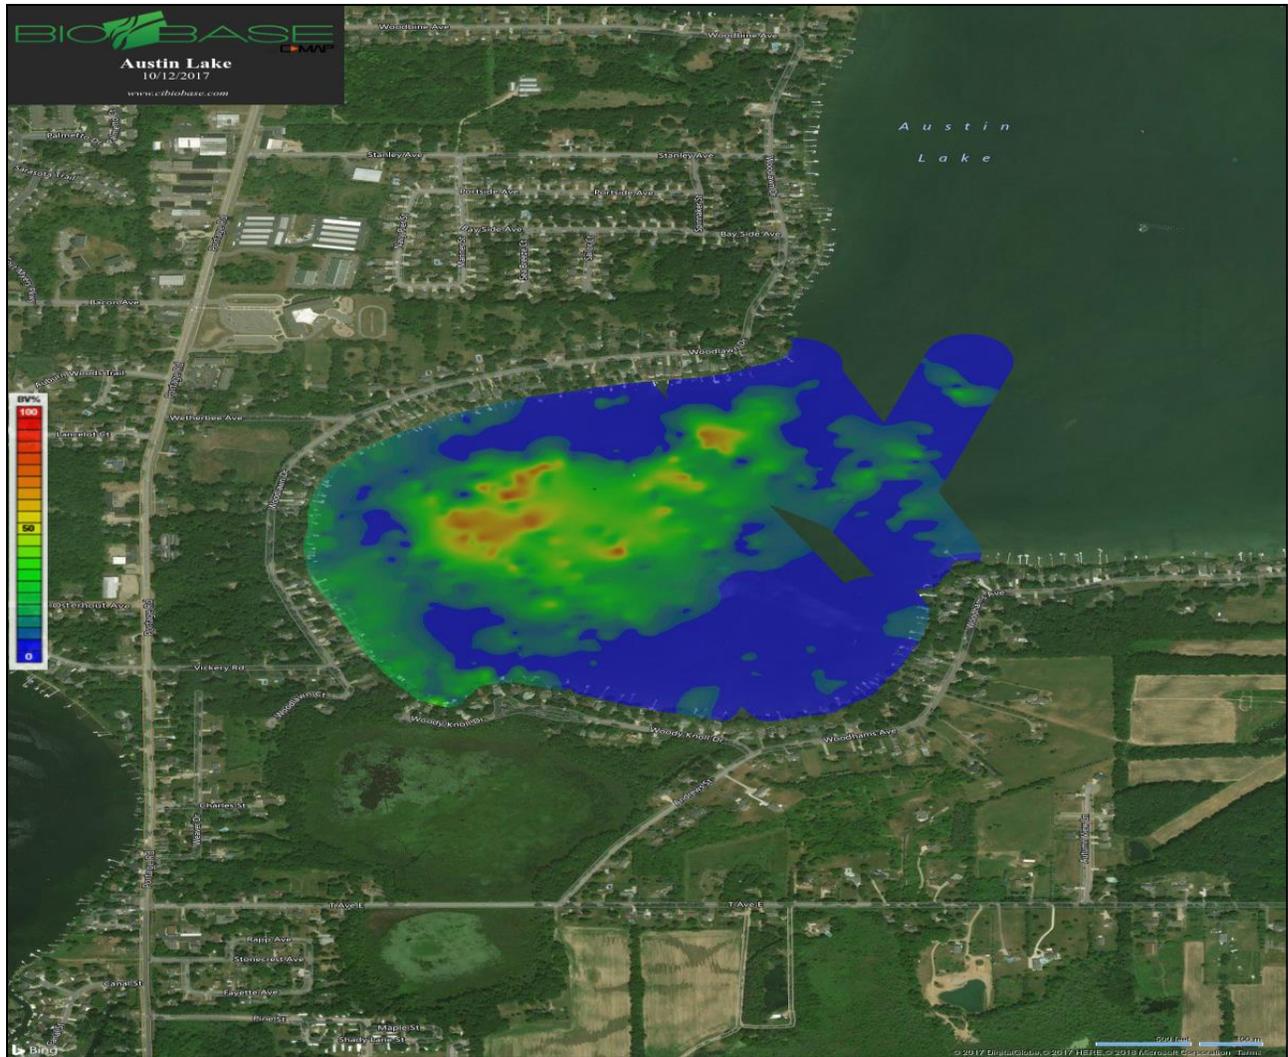
An aquatic vegetation biovolume scan of the South Basin of Austin Lake was conducted on October 12, 2017 using a Lowrance HDS 8[®] sonar unit with GPS. BioBase software was used to create an aquatic vegetation biovolume map (Figure 3) of the South Basin as a baseline. The biovolume map below shows the relative aquatic vegetation biovolume in the South Basin of Austin Lake. The blue areas represent no vegetation whereas green areas represent low-growing vegetation and red areas represent high-growing vegetation. Table 9 shows the percentage of the various biovolume categories that exist in the South Basin area. The majority of the South Basin is either non-vegetated (blue color) or has low-lying aquatic vegetation (green).

Figure 3. An aquatic vegetation biovolume scan map of the South Basin Austin Lake (October 12, 2017. RLS). Note: This scan will be completed again around the same time in 2018.

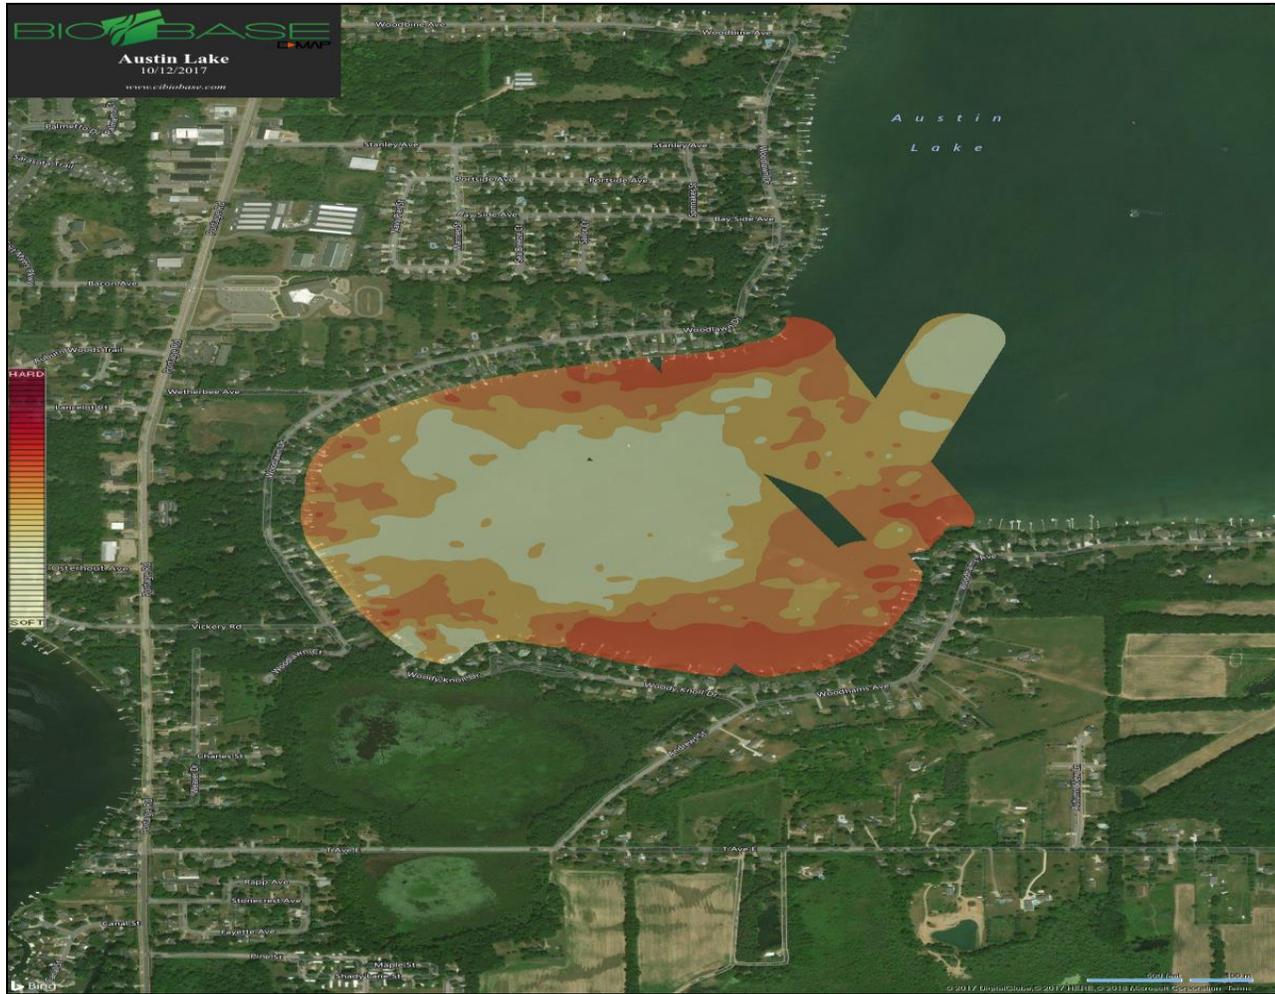
A sediment bottom hardness scan of the South Basin of Austin Lake using a Lowrance HDS 8® sonar unit with GPS software was used to create an aquatic sediment bottom hardness map (Figure 4) of the lake on October 12, 2017 as a baseline. The areas light beige in color represent soft, mucky bottom whereas areas that are red represent firmer bottom. Colors in the orange family represent intermediate bottom hardness types. This baseline information is important since it allows us to determine if the aeration system has reduced muck throughout the lake bottom in the future. Table 10 shows the area of the South Basin occupied by each sediment hardness category.

Figure 4. A bottom sediment hardness map of the Austin Lake South Basin (October 12, 2017. RLS).

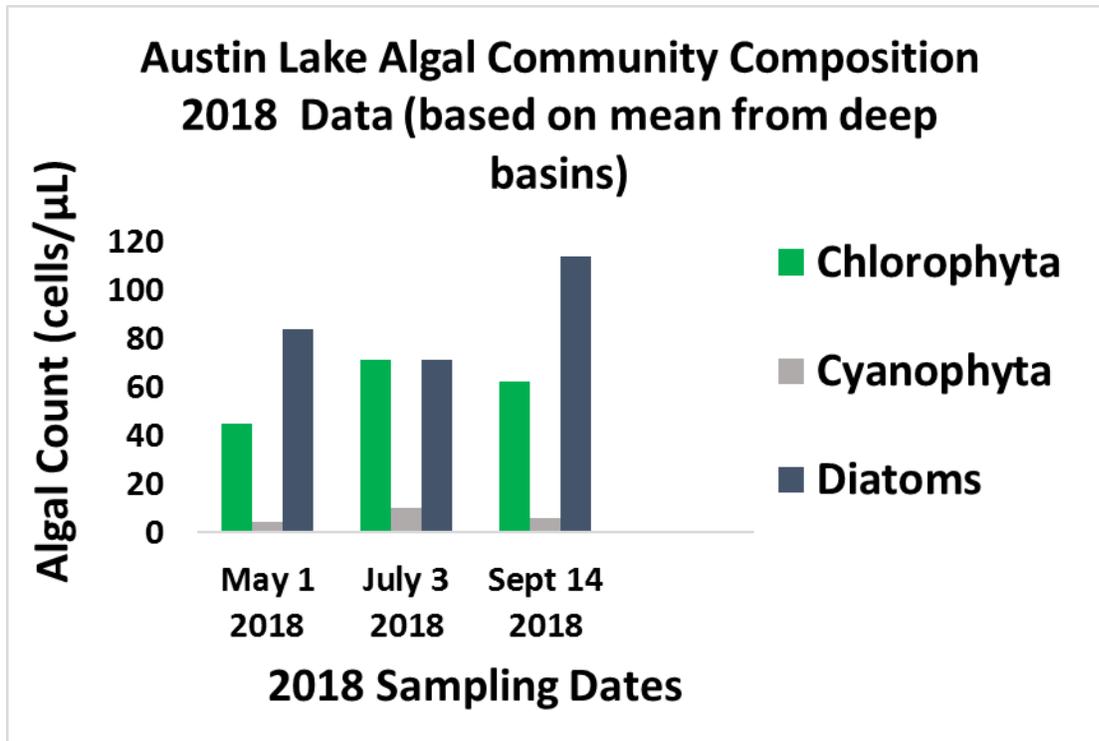
The algal genera were determined from composite water samples collected over the deep basins of the South Basin of Austin Lake on May 1, 2018, July 3, 2018, and September 14, 2018 were analyzed with a Zeiss® compound bright field microscope. The genera present included the Chlorophyta (green algae): *Scenedesmus* sp., *Chlorella* sp., *Mougeotia* sp., *Rhizoclonium* sp., *Staurastrum* sp., *Cladophora* sp., and *Radiococcus* sp., The Cyanophyta (blue-green algae): *Gleocapsa* sp.; the Bascillariophyta (diatoms): *Navicula* sp., *Rhoicosphenia* sp., *Synedra* sp., *Cymbella* sp., and *Tabellaria* sp. The aforementioned species indicate a diverse algal flora and represent a good diversity of alga but less blue-green algae is desirable.

Figure 5. Relative abundance of algal taxa in the South Basin of Austin Lake (May 1, 2018, July 3, 2018, and September 14, 2018).

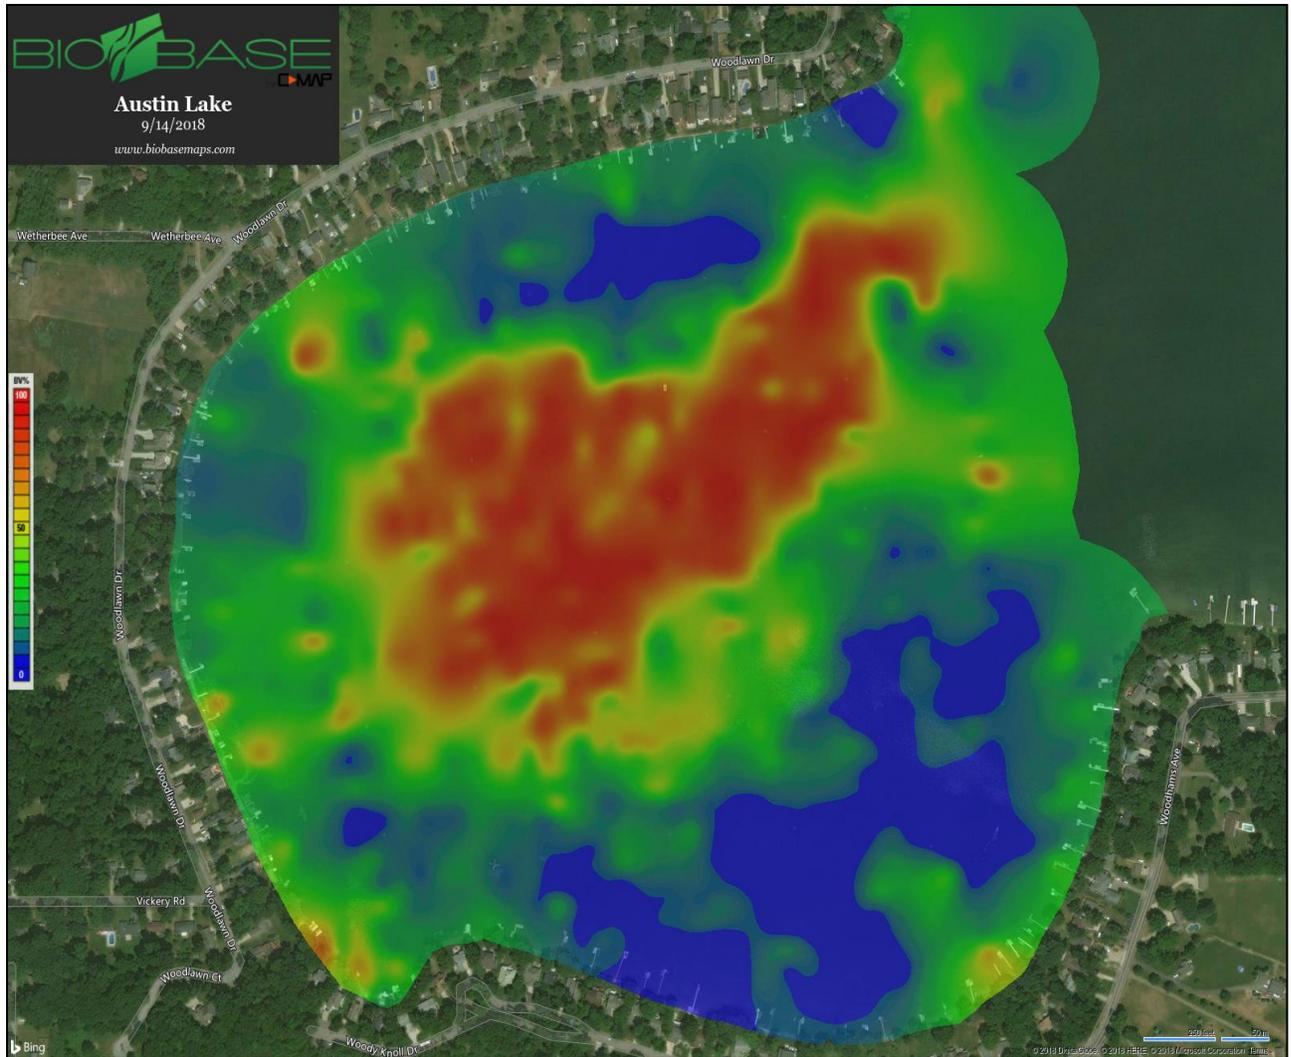
An aquatic vegetation biovolume scan of the South Basin of Austin Lake was conducted on September 14, 2018 using a Lowrance HDS 8® sonar unit with GPS. BioBase software was used to create an aquatic vegetation biovolume map (Figure 6) of the South Basin as a baseline. The biovolume map below shows the relative aquatic vegetation biovolume in the South Basin of Austin Lake. The blue areas represent no vegetation whereas green areas represent low-growing vegetation and red areas represent high-growing vegetation. Table 36 shows the percentage of the various biovolume categories that exist in the South Basin area. The majority of the South Basin is either non-vegetated (blue color) or has low-lying aquatic vegetation (green).

Figure 6. An aquatic vegetation biovolume scan map of the South Basin Austin Lake (September 14, 2018. RLS).

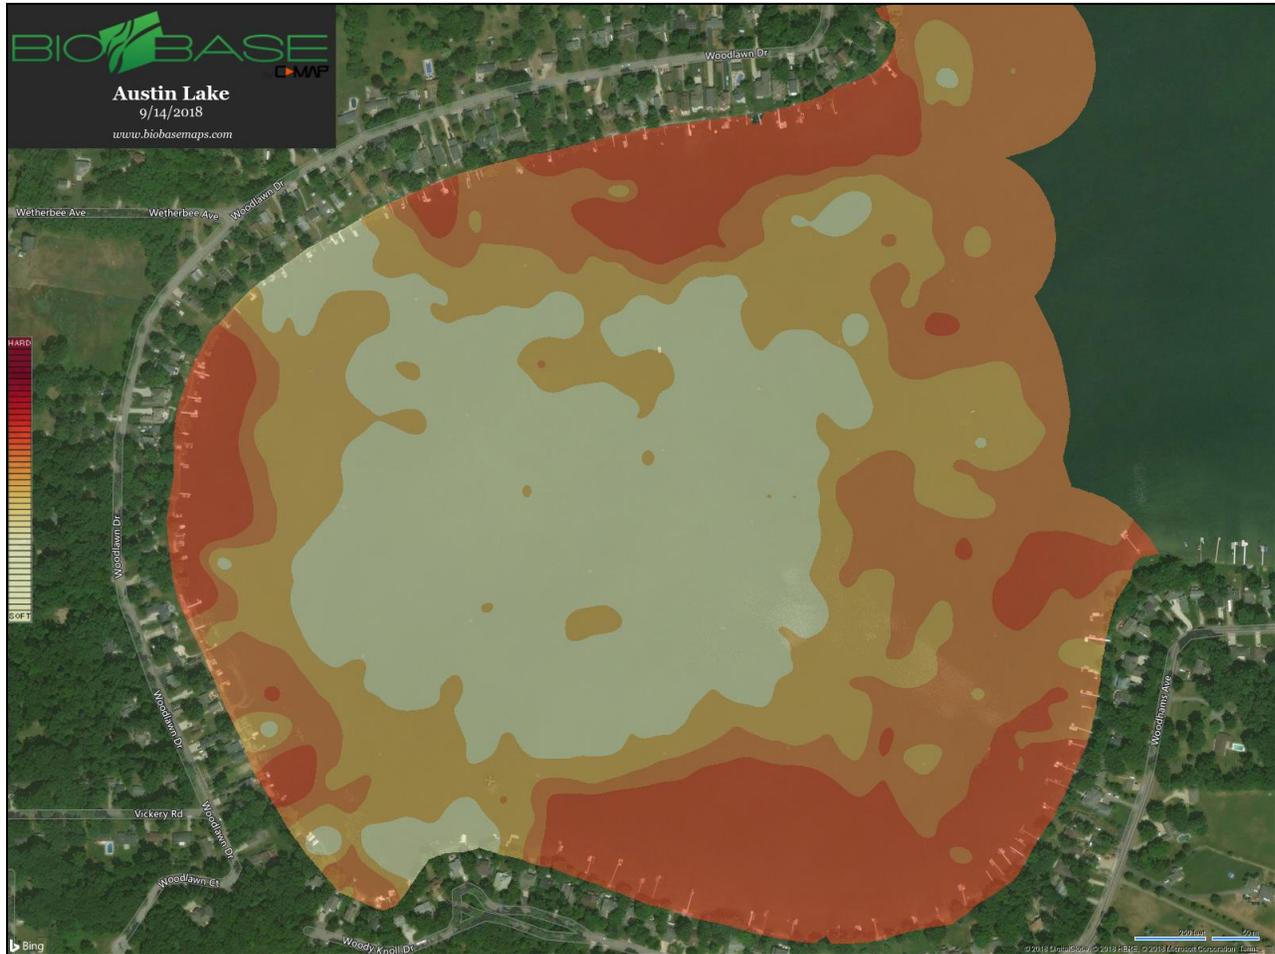
A sediment bottom hardness scan of the South Basin of Austin Lake using a Lowrance HDS 8® sonar unit with GPS software was used to create an aquatic sediment bottom hardness map (Figure 7) of the lake on September 14, 2018 as a post-aeration scan. The areas light beige in color represent soft, mucky bottom whereas areas that are red represent firmer bottom. Colors in the orange family represent intermediate bottom hardness types. This information is important since it allows us to determine if the aeration system has reduced muck throughout the lake bottom in the future. Table 37 shows the area of the South Basin occupied by each sediment hardness category.

Figure 7. A bottom sediment hardness map of the Austin Lake South Basin (September 14, 2018, RLS).

The bottom hardness scan was conducted in 2018 as in 2017 and the results are shown in Table 40 below. The sediments with the hardest readings are in the .3-.4 and >.4 categories. These are relative hardness categories based on the sediment algorithm data calculations from the software. Measurable increases in the firmest categories were noted in 2018 with only a minor increase in the softest category. This supports the muck loss data for 2018 which was favorable. This data indicates that the LFA system is effectively reducing soft muck in the bottom of the South Basin.
