Understanding Water Quality Impacts of Vermont's Back Roads: a research summary for policy makers

Presentation to the Vermont House
Transportation Committee

January 30, 2015

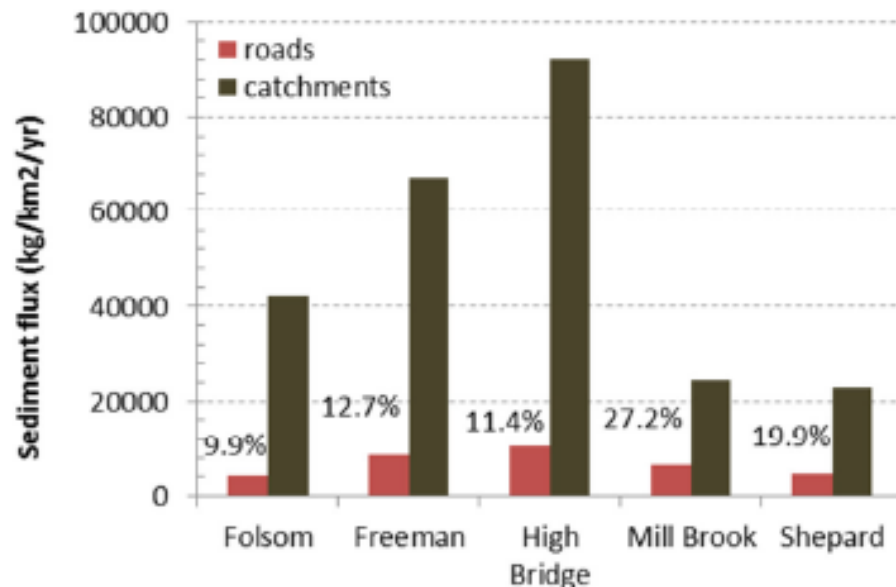
Suspended Sediment

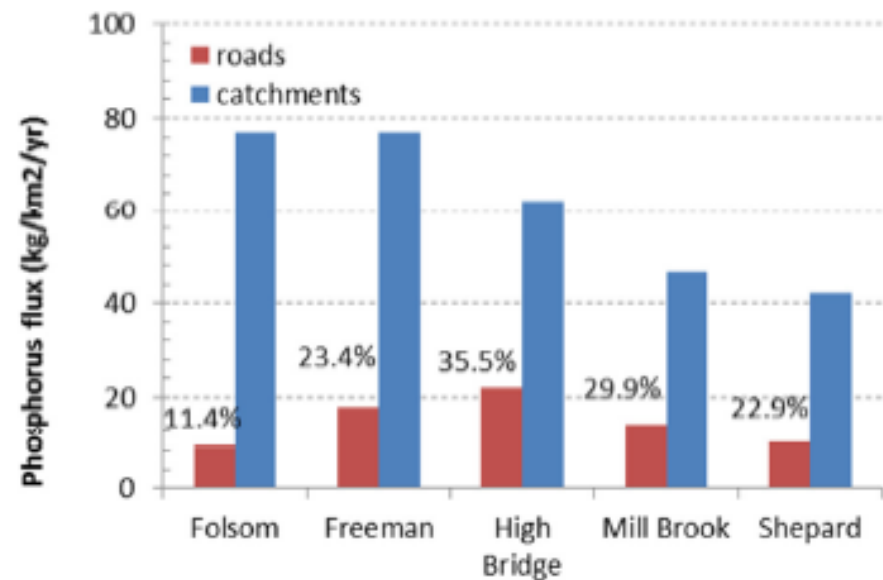
Total Phosphorus

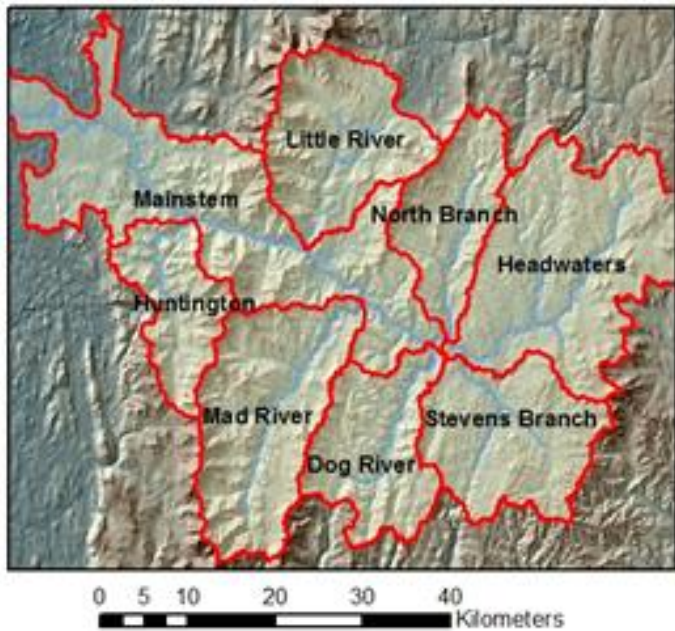
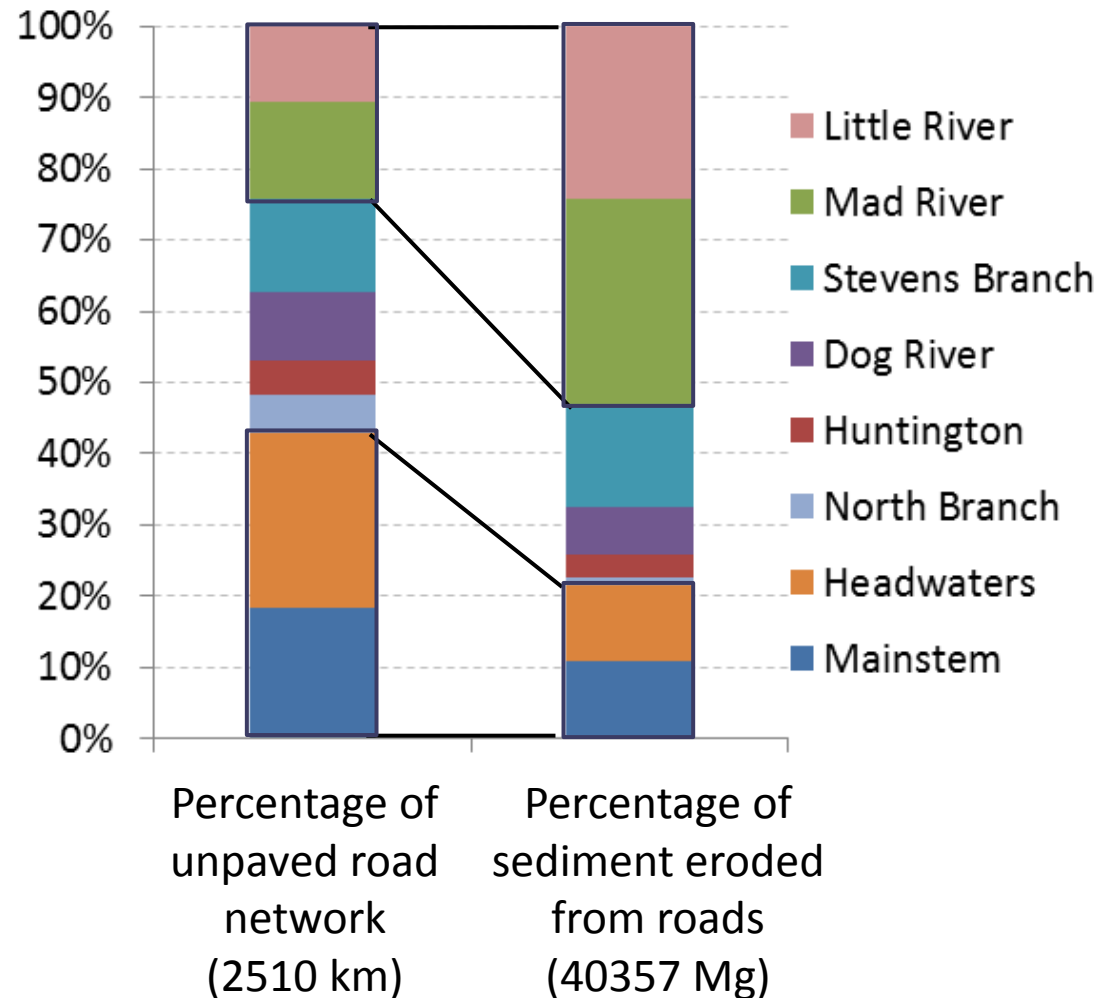
Identifying “hot spots” of erosion

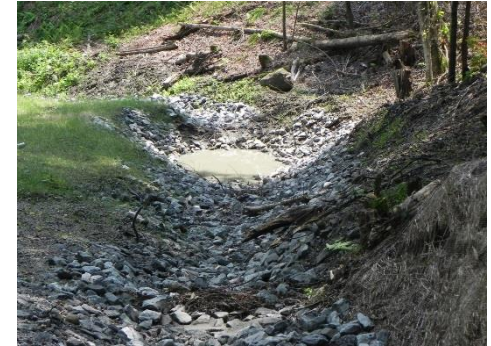
intact

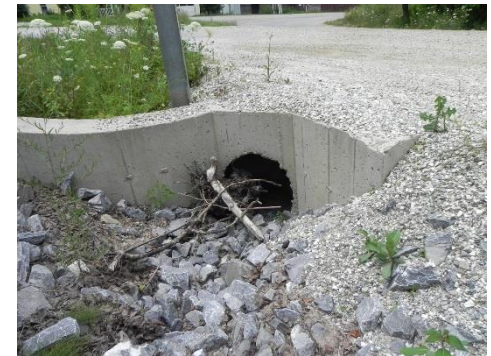
compromised

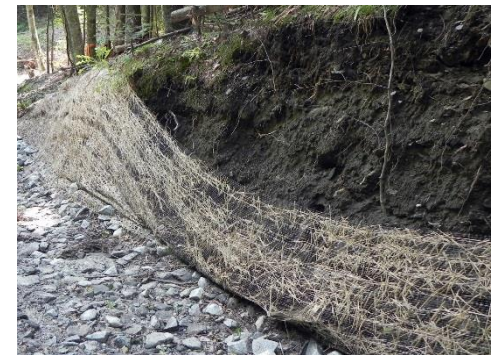
failed

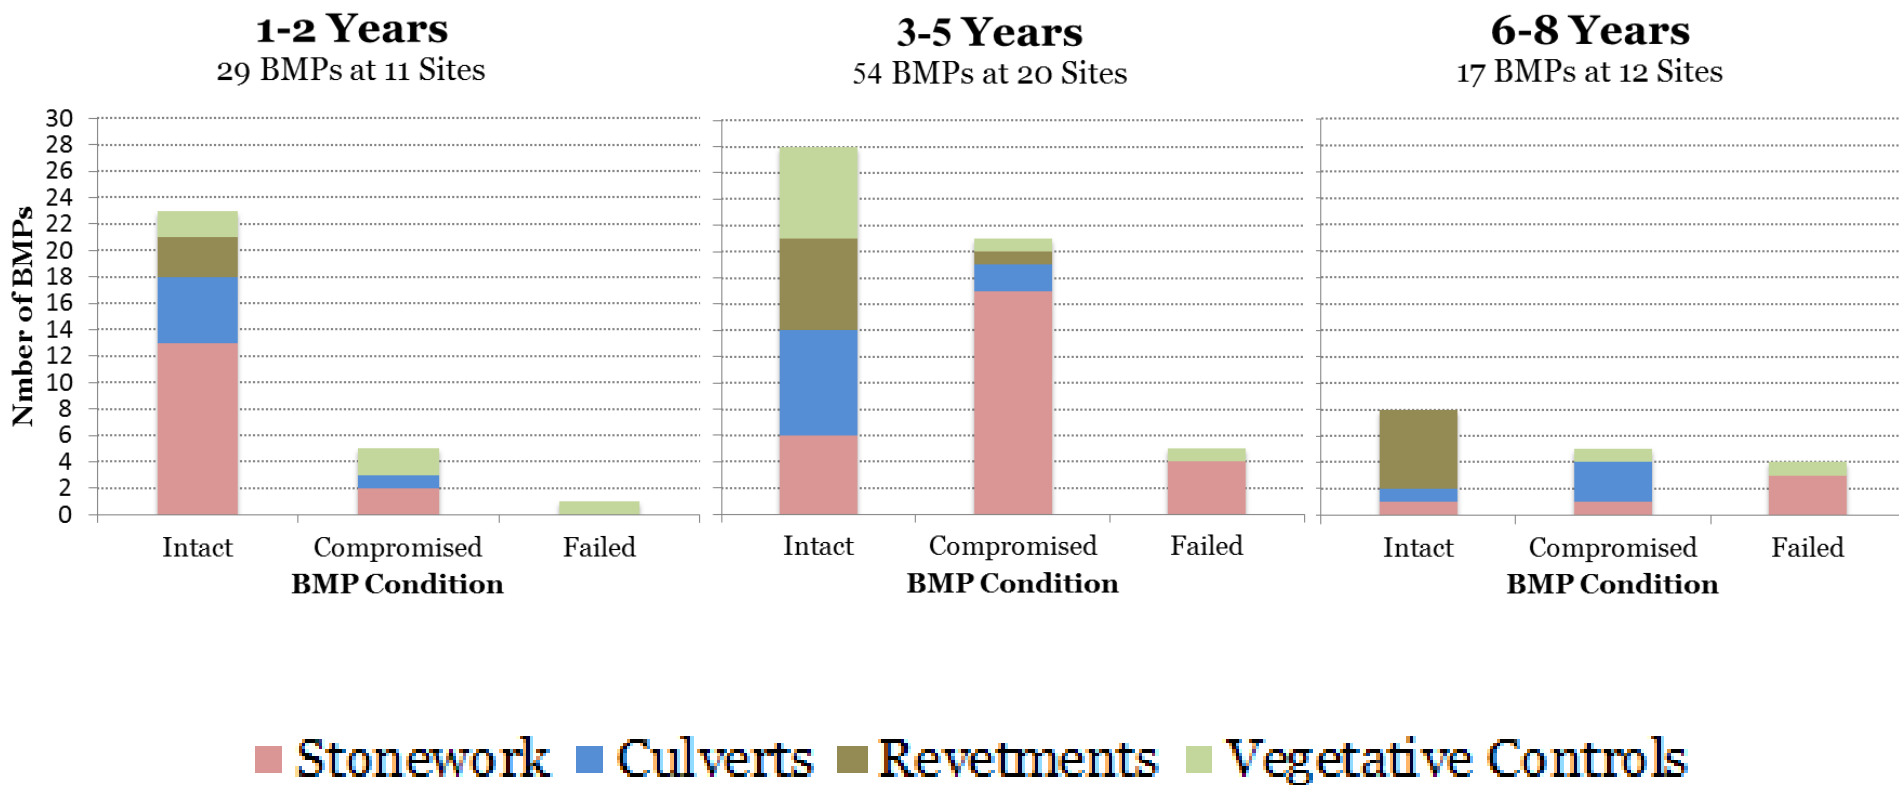
BMP persistence with time

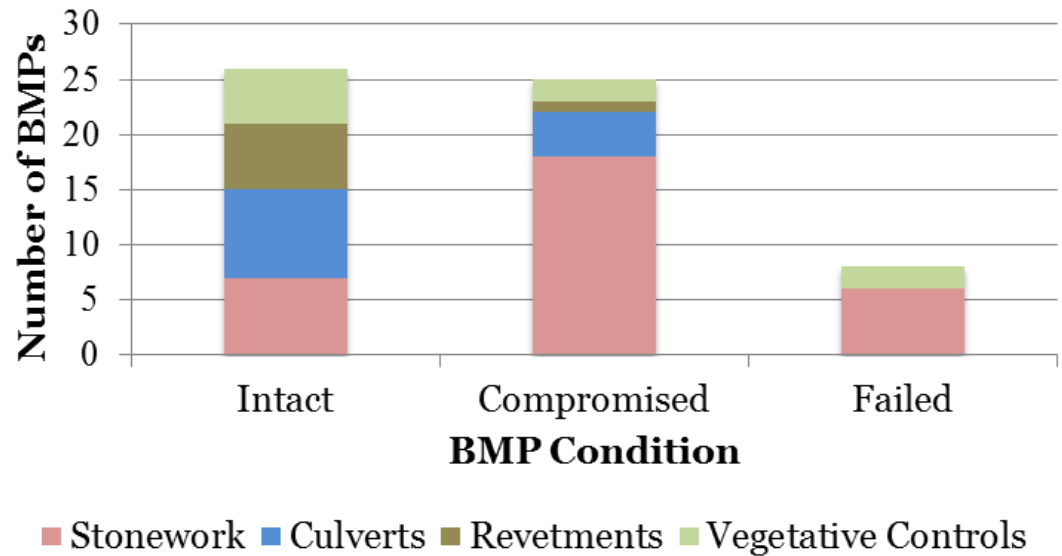
BMP effectiveness with flood exposure

Exposed to flood events

59 BMPs at 23 Sites

Average Age 4.8 years, SD 1.6

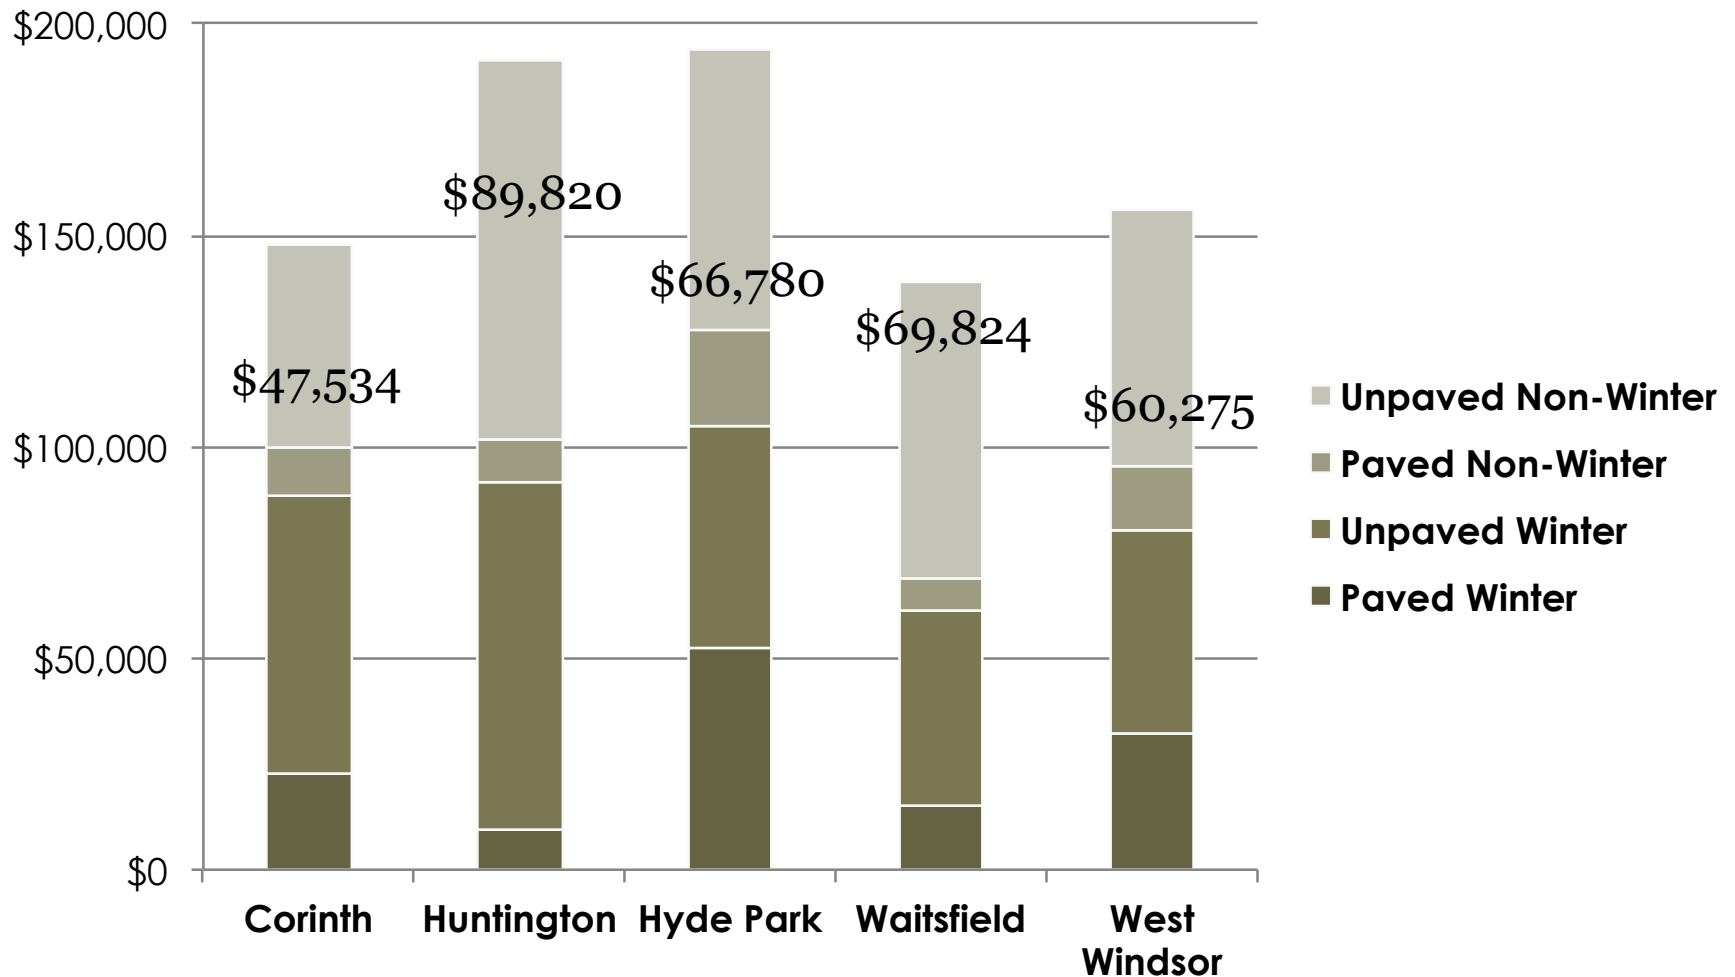
Annual road crew salary

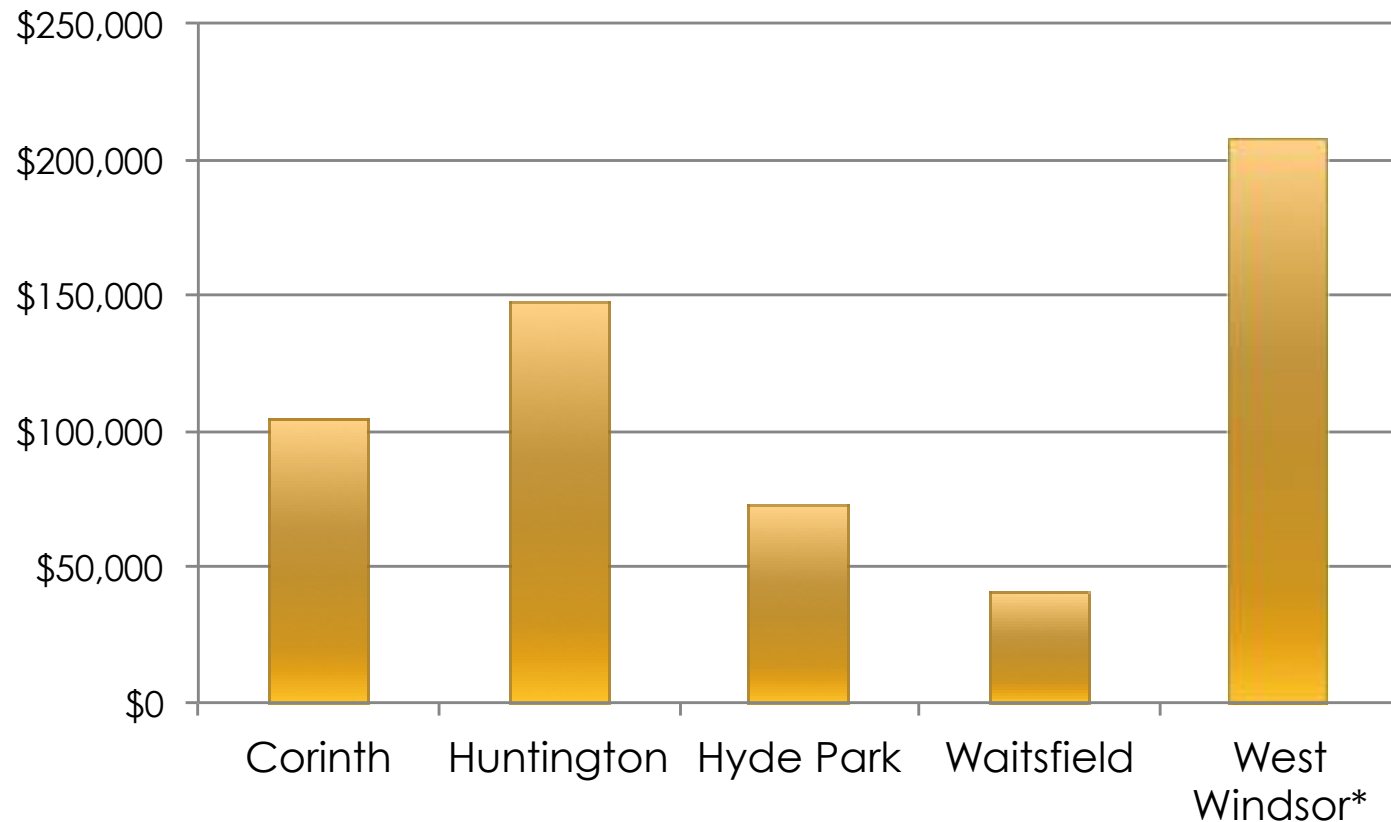
Annual materials costs

Non-Winter Unpaved Road Maintenance

* West Windsor materials total includes \$55,686.81 of itemized equipment rental, materials and trucking as a needed after a 2013 flood event

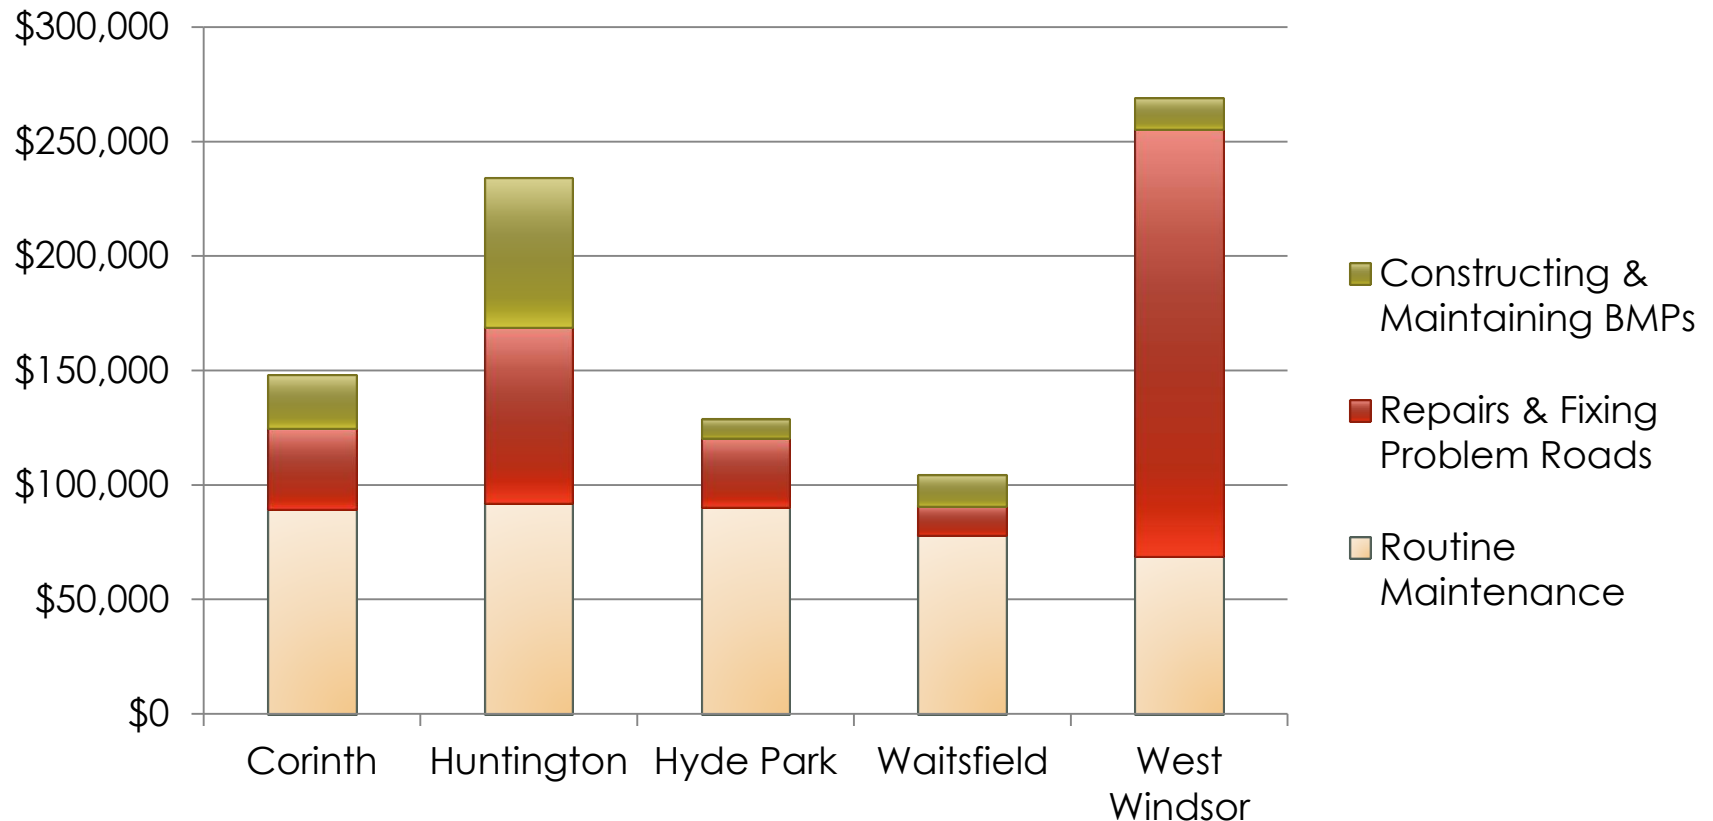
Total salary and materials costs unpaved non-winter road work
