**ASSESSMENT OF JAHN PERMEABLE MORTAR SYSTEM IN A
HISTORIC BRIDGE ABUTMENT APPLICATION**

Report 2015 – 10

June 2015

Reporting on Work Plan 2011-R-05

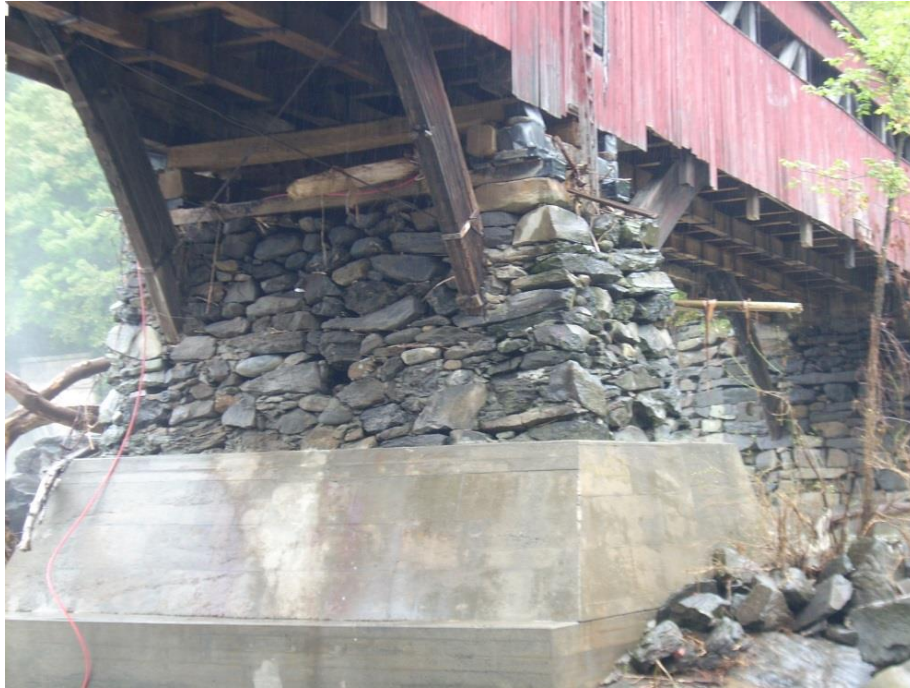
Figure 19 Pier before Tropical Storm Irene in 2011

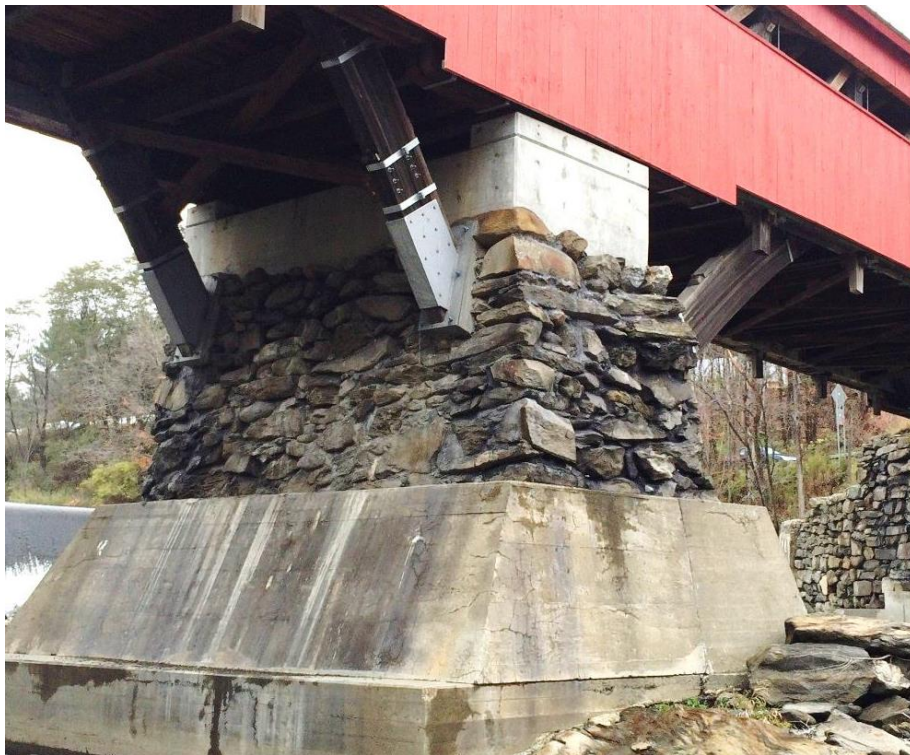
Another purpose of using the Jahn products was to strengthen the dry-laid stone pier and abutment to preserve the overall historic appearance of the bridge. Concerns were that the mortar would be obvious from a distance. Observations at various distances from the substructure units gave an appearance of dark joints between stone (Figure 19 and Figure 20). The mortar and pointed stones were virtually invisible to the eye from afar. Even up close, the dark grey color of the mortar has aged in a way that it is not obvious in most places on each substructure unit. Places where the mortar is visible are where there were large gaps in the dry-laid stone (Figure 21).

Figure 20 Pier after Construction in 2014
