Ripton Comprehensive Flood Resilience Project

Linked Policy and Projects

The Project in a Nutshell:

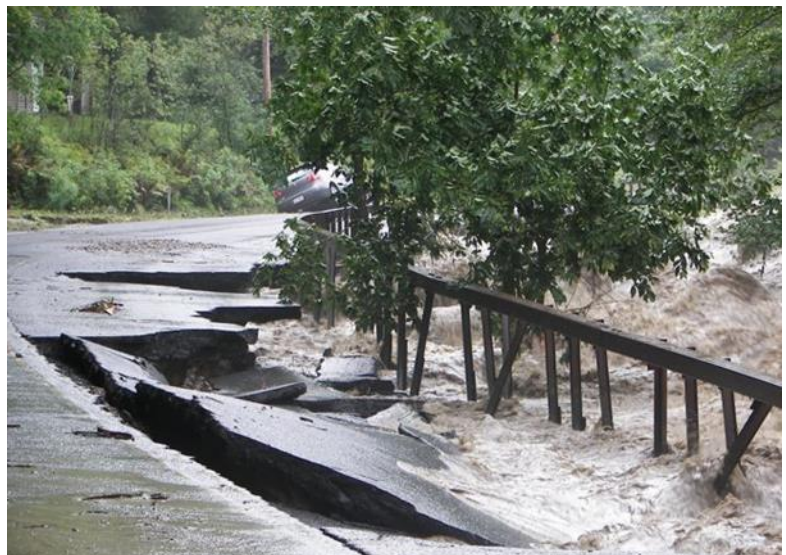
Fig 1: East Middlebury River flooding Rte. 125 in Ripton (2008)

Ripton's vulnerability to flooding became apparent well before Tropical Storm Irene devastated much of the state. In 2008, Ripton experienced two 100-year floods in one year. A 100-year flood is a flood event that has a 1% chance of occurring in any given year. These flood events heavily damaged Route 125, caused significant erosion, and threatened property, public infrastructure, and life (See Figure 1). The town of Ripton decided that they must take action to reduce their vulnerability to the increasing risk of flood damage.

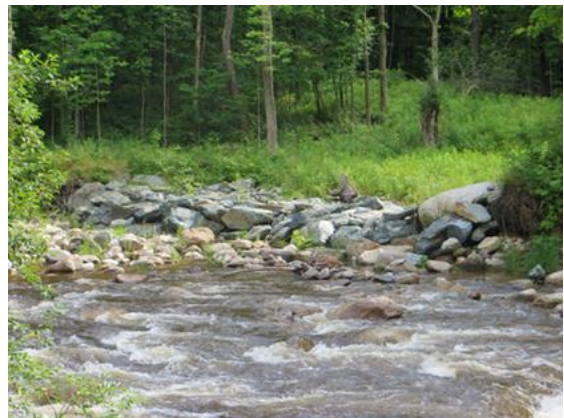
Figure 2: Flood chute opening

After securing funding from the state and FEMA, the town began construction in 2009. They installed 700 feet of rip rap along the river bank in the village area, which prevents erosion and enables water absorption. They also opened up a flood chute, accessed on the left side of the river bank (See Figure 2). The flood chute is designed to enable the river to access its natural floodplain, deposit sediment, and serves to dissipate excess energy within the river. Additionally, the Middlebury Area Land Trust coordinated conservation easements upstream from town, within the natural floodplain area (See Figure 3). This conserved floodplain was accessed during Irene, serving its purpose of dissipating the river's energy, thereby protecting the town from damage. Amy Sheldon remarked, "...these guys dodged a bullet when Irene came because of this". This project would not have been successful without productive collaboration between state, federal, and local government. Barry Cahoon, a river scientist at Vermont Agency of Natural Resources, cited "...a positive, mutually beneficial partnership with the community..." as a significant benefit of the project.

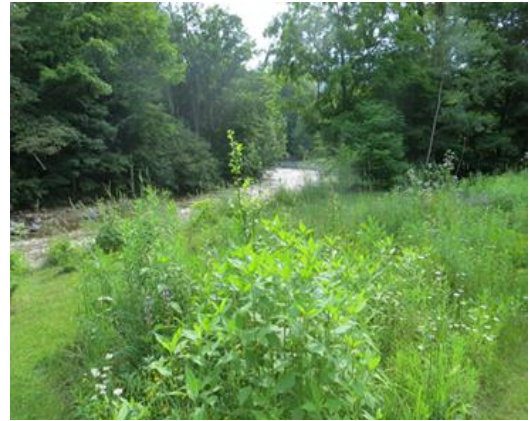
Figure 3: Conserved floodplain along the E. Middlebury

This project was highly successful in achieving its main goal of mitigating flood risk in Ripton. Further, the cost of the project was miniscule compared to the avoided cost of damages from Tropical Storm Irene. The project has also resulted in conserved floodplain upstream. The Vermont Department of Environmental Conservation asserts that ensuring floodplain access is key to successful river management and flood hazard mitigation. According to the Vermont Department of Environmental Conservation, "Without floodplain access, which serves the essential purposes of slowing floodwater and storing sediment, stream banks are subjected to the full power of flood flows, leading to extensive fluvial erosion". Also, the work that has been done provides an educational benefit to the local community.
